DISTRIBUTING CO., INC.

SERVICE NOTE KDK 2025A MK11

SERVICE NOTES/HINTS AND KINKS

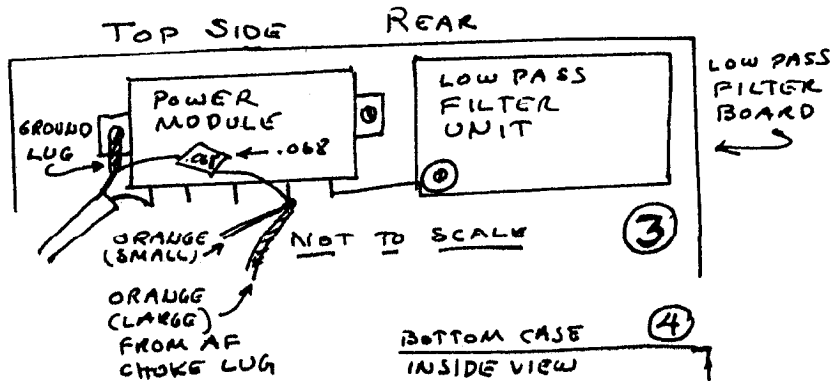
Drawing #3 Place a .068 mfd mylar capacitor of at least 50 volt rating on the wire protruding from the power module which has the orange wire coming from the AF filters and solder in place. Connect the other end of the capacitor to the ground lug bolted on the left hand mounting tab of the power module.

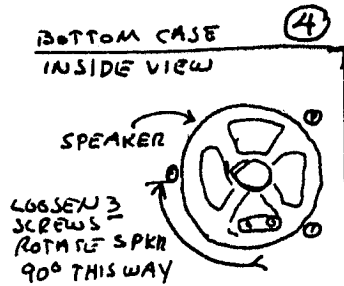
Drawing #4 shows the speaker mounting and how it is turned 90 degrees.

After the choke and capacitor have been installed, loosen the three screws holding the speaker to the outside bottom cover and rotate the speaker 90 degrees inward so that the terminal lugs are now placed on the inside, rather than facing forward or to the rear. See drawing #4. Then retighten the three screws. If the speaker is not moved so that the terminals are placed as shown, the terminals might short against the newly installed choke.
